SOCIETY NEWS & VIEWS

SPRING ISSUE
May 2016

Rolle Canal - Furzebeam Permissive Path -
Retaining wall failures
Roy Sutton BA, MSc, CEng, MICE
8th September 2012

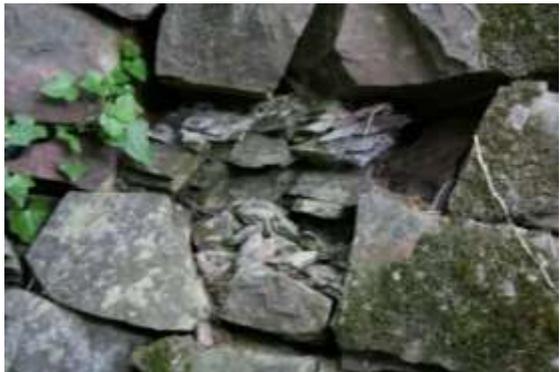
1.3.1)

Poor material

Occasional lumps of mudstone are mixed in with the generally competent shale blocks.

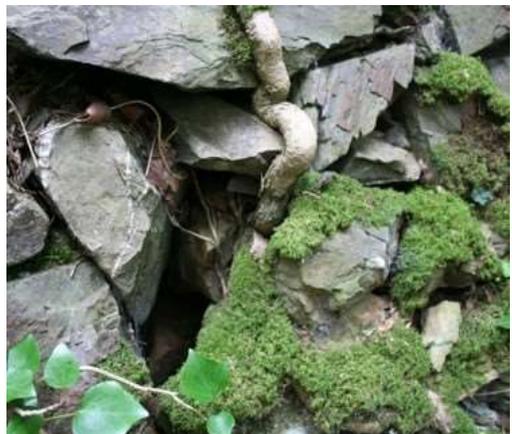
1.3.2) Roots

The ivy roots shown in the following two pictures are destructive as they get into cracks in the stones and force them open, destroying the stones.

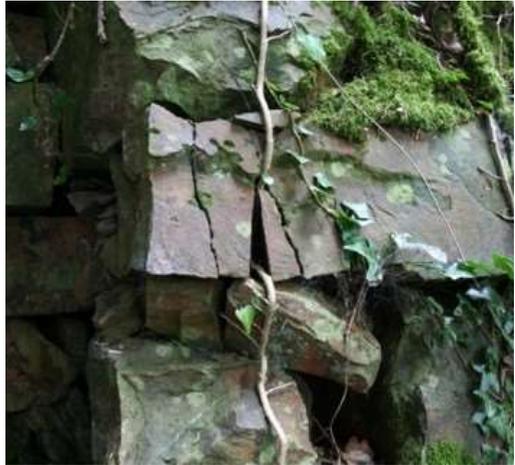
1.3.2) Roots continued

Even more destructive are the underground roots of saplings.

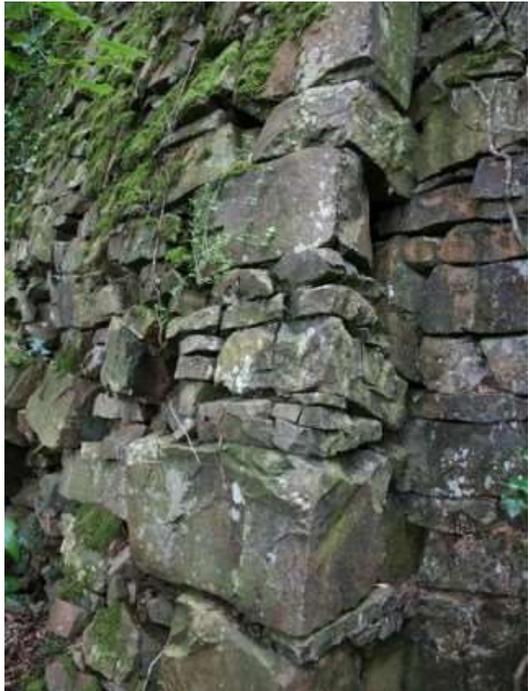
1.3.3)

Poor Construction / Repair

Occasional buttresses appear to have been added after most of the construction.

They may have been repairs to earlier failures.

The buttress quoins in the picture are poorly bonded to the body of the wall. The buttresses also use a messy combination of very small and very large stones. As well as being untidy this inhibits redistribution of load

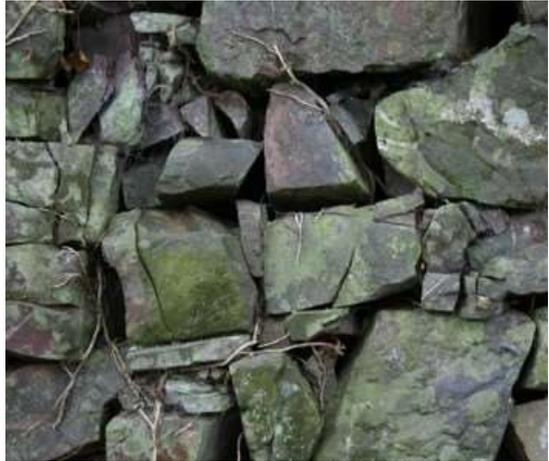
1.3.4) Shattering under load

This picture shows the distribution of load causing shale blocks to shatter.

The next stage after this is a failure mechanism.

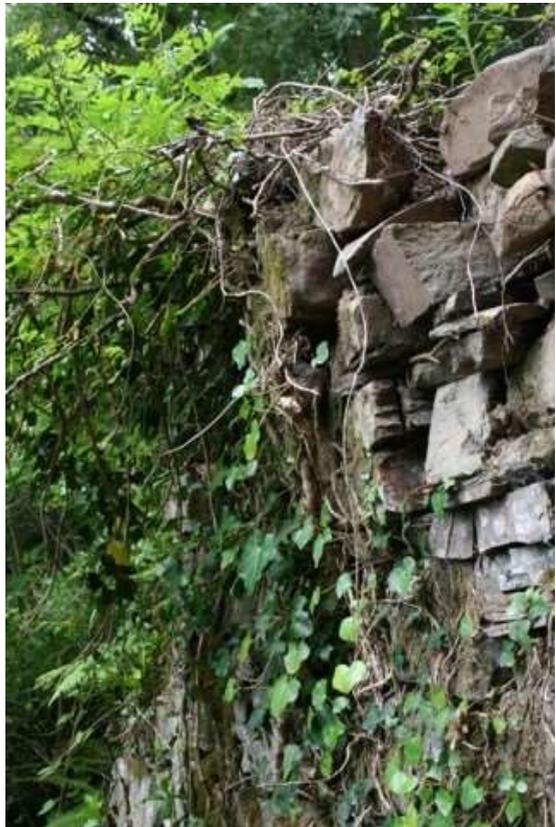
1.3.5) Frost-heave and vegetation

This picture shows a failure caused by a combination of two distinct effects.

Frost-heave occurs when saturated soil freezes and expands, so pushing the top of the wall slightly outwards with inexorable force. The wall movement leaves the soil loose. It consolidates. Then it freezes again and the wall is moved incrementally further. Over many years the top of the wall is destabilised.

Root balls also destabilize the top of the wall.

Frostheave assists their growth. But even in the short term they can do enormous damage to the top of the wall.

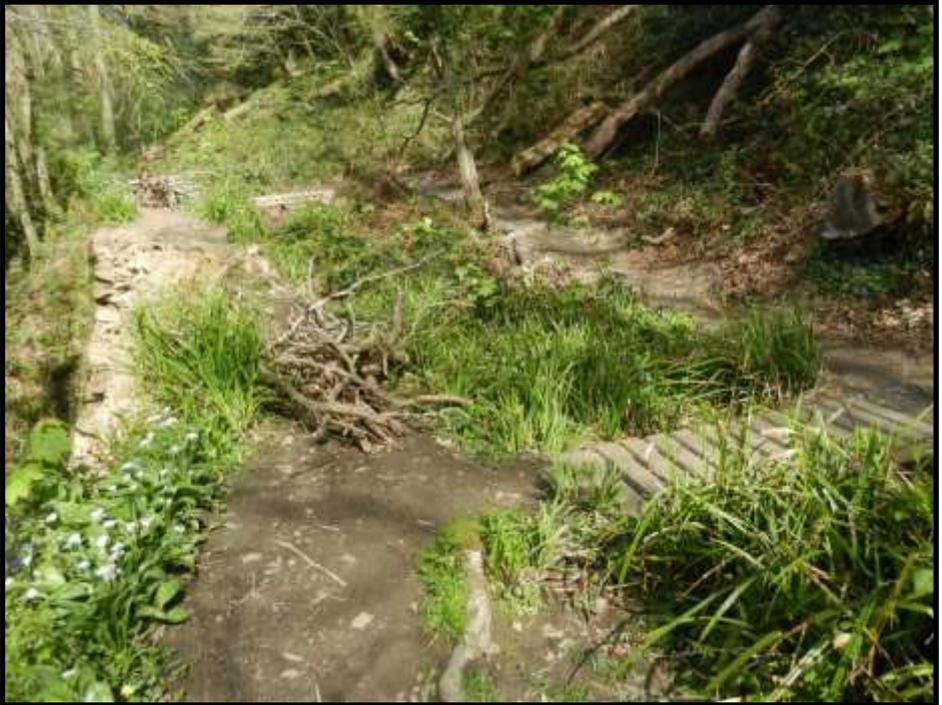
The chairman took the photograph above showing the completed diversion. Piles of brash have been placed on either side of the collapsed section to deter people from walking along the dangerous edge,
