The **R**oile **C**anal & Northern Devon Waterways Society

SOCIETY NEWS and VIEWS

**AUTUMN ISSUE
November 2013**

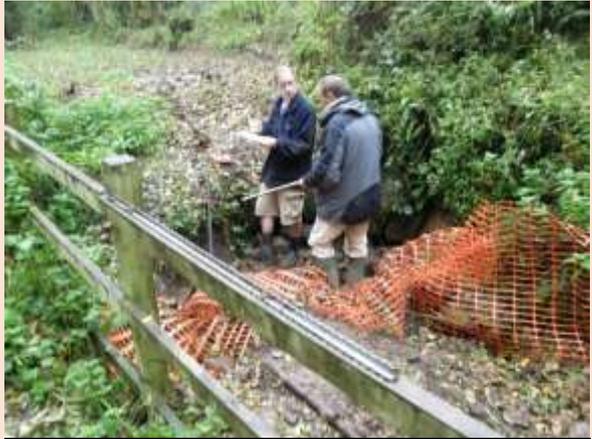
Greg Smith and Tony Barnes measuring the dimensions of the damaged wheel pit vault in October, 2013.

Maintaining security and safety around the damaged wheel pit vault is also a problem to be overcome.

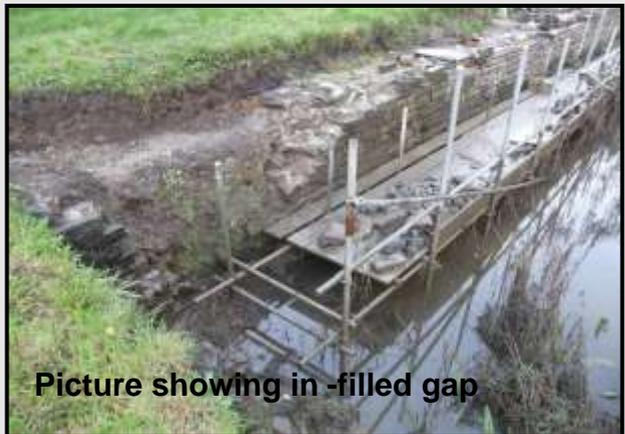
In the section most recently under repair, it was initially thought that this short stretch of wall was probably damaged as a result of a tree growing in it, falling over and its roots ripping the wall out. The face of the wall had gone but it appeared that much of the back had gone as well. Work started to clear the infill only to reveal that there was no masonry here at all, only a gap. This hole in the wall was excavated until at last firm, level masonry was reached several

feet down and well below the level that water would have been when the lock gates were working properly.

It appears that this gap was deliberately cut in the wall and its stone removed. At the bottom of the gap running through the width of the wall were some earthenware field drains. While all this excavation was going on water was draining out of the dug ground. Stating the obvious, water flows downhill. It continues to do this until it meets an obstruction, in this case all along the back of the wharf wall. Building drainage pipes into the wall below water level when the canal was in use would be pointless, so why and when was the gap cut through?

At present, work is under way to repair a section which has raised a number of questions. Having cleared all invasive vegetation, most of the rebuilding of the wharf wall has involved lifting off loose stones and removing poor mortar until a firm surface has been reached on which to rebuild. In most instances this has been more to the face than the back of the wall since this is less exposed to the elements. In one or two places the mortar was in a very poor state which meant that the whole width of wall needed taking down and rebuilding although effectively the wall was still there.

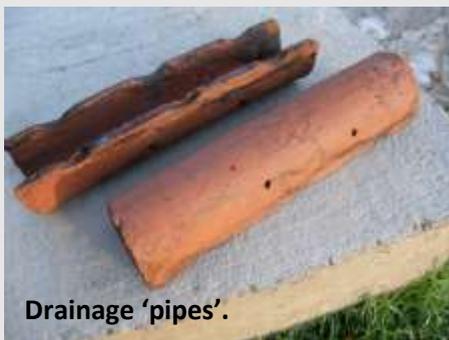
Drainage 'pipes'.

The drainage 'pipes' themselves are interesting since they were laid like a child's railway set tunnel. They are 'u' shaped and have a scalloped bottom edge to allow water to seep into the enclosed space and only four very small holes in the 'roof' to allow water in.

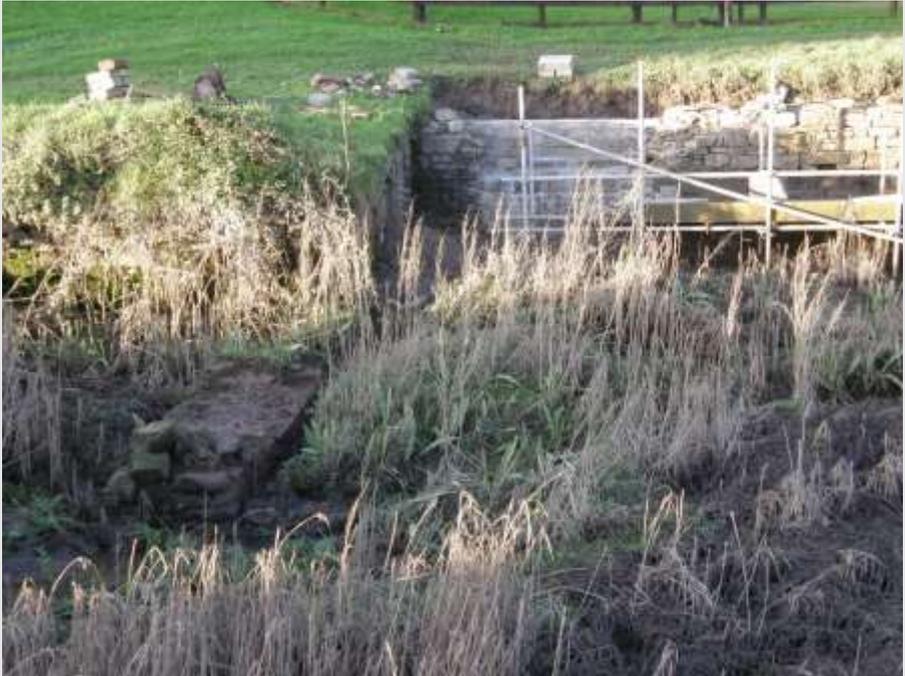
The picture above shows the hole in the wall, (centre background) in the process of being rebuilt and the unexplained section running into the middle of the basin to the left of the picture.

This gap in the wall is not far from another odd section of damaged masonry which defies explanation and is again below the level of the water when the canal was in use. I suspect that this odd length of wall was originally the end of the wharf

basin before going into the canal proper, but it was realized that the wharf basin capacity was insufficient for the number of boats using it, so the wall was taken down to below the depth which would cause obstruction and the wharf extended.

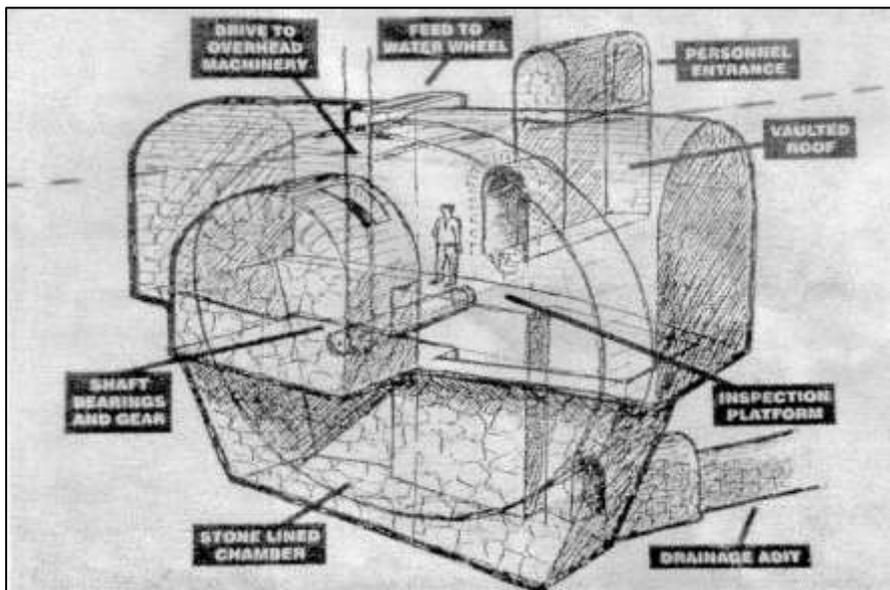
(Diagram of Merrifield wheel pit by kind permission of Bude Canal)

The diagrammatic drawing above is of the wheel pit on the Bude Canal. Since the Bude Canal and Rolle Canal were built by the same engineer, James Green, there is little reason to suppose that the wheel pit at Ridd differs significantly from this one, other than its dimensions.

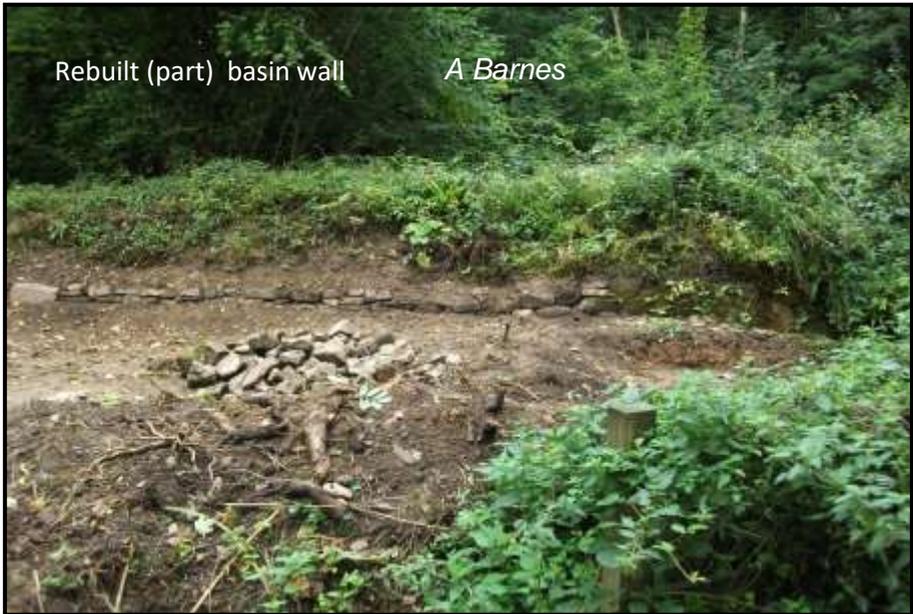
Whilst on site, volunteers Jeremy Gillbard and Adrian Pope partially rebuilt the stone wall of the basin, so that its extent could be clearly seen.

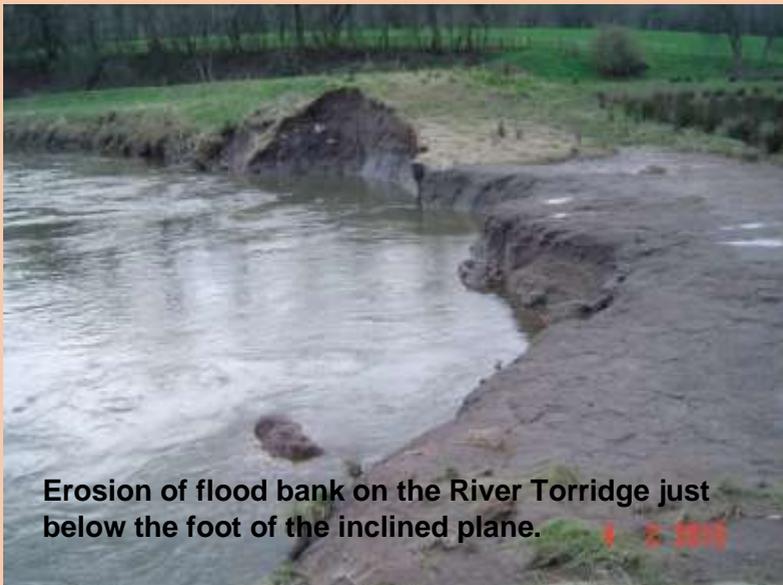
Erosion of flood bank on the River Torridge just below the foot of the inclined plane.

First, erosion of the flood bank protecting the field from high tides in the Torridge called for emergency action from the Environment Agency to reinforce the bank with rock armour. (Being a major river, flood protection was the responsibility of the EA. At the last moment, EA realised that it would be cheaper to purchase the field from the farmer and allow it to flood rather than repairing the bank, so that is what they did, and the rock armour was diverted to a storage point beside Halfpenny Bridge where it is stockpiled ready for its eventual use which may be to protect Northam Burrows from the sea.

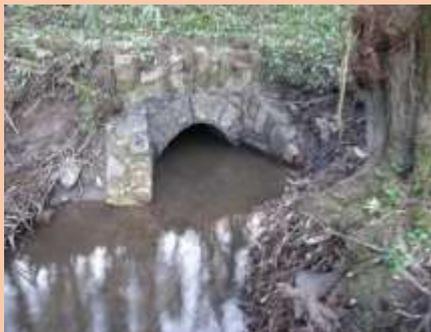
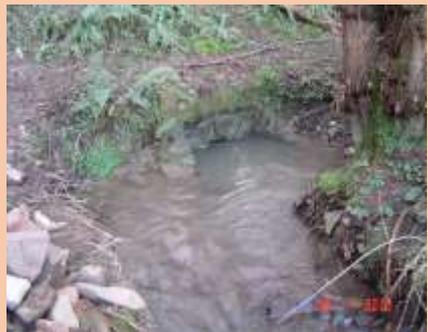
However, before any of this interpretation work could be started, the second weather event intervened in the form of a torrential rainstorm that blocked the culvert (pictured below) carrying a minor stream under the Tarka trail embankment on its way to the Torridge. With the culvert blocked, the embankment formed a dam, and a great lake filled up between the Tarka trail and the main road, which event brought DCC Highways into the picture in double quick time.

Their emergency repairs, in addition to the un-blocking of the culvert, comprised re-aligning and deepening the stream bed beside the canal basin, with the result that when they left, the site of the basin consisted largely of a great heap of excavated spoil in the midst of a swamp. One exciting revelation was that, projecting from the spoil heap, was a cast iron bar which an archaeologist member spotted and recognised as one of the original iron rails on which tub boats had travelled up and down the incline some 180 years ago.

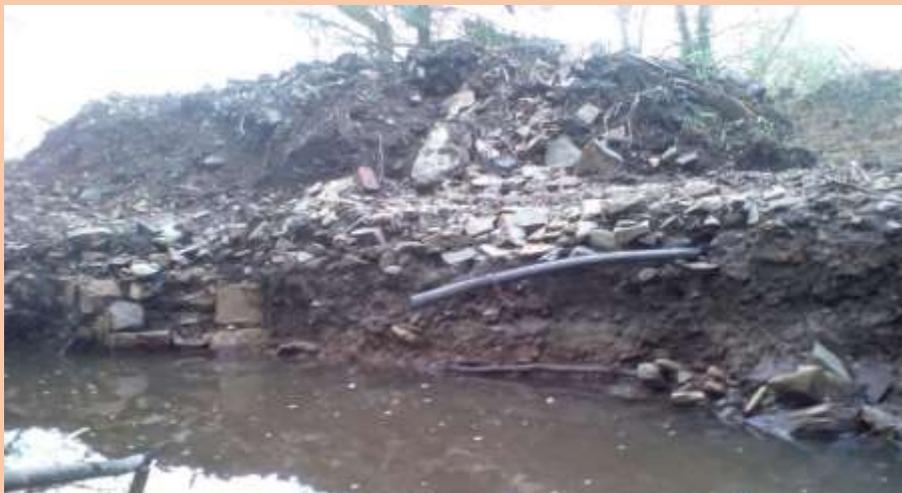
Spoil heap left behind following DCC Highways delicate and sensitive clearing of the blocked culvert.

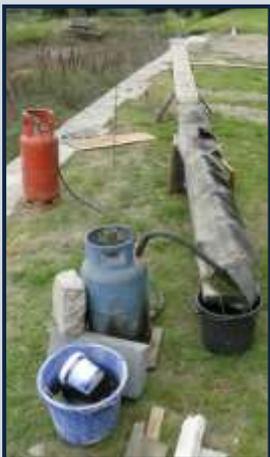
He also managed to borrow, from a local boat-builder friend, a homemade steamer – an old liquid gas cylinder with a heavy duty gas burner ring welded to the bottom and an outlet at the top. The old cylinder was filled with water and the burner at the bottom connected to another cylinder containing butane gas. The timber to be bent was

inserted into one end of the inner tube which had been cut across to create a tube, (somewhat curved but beggars can't be choosers!). This was then propped up at an angle and connected to the steamer by means of a length of old washing machine hose.

Heath Robinson would have been proud of such a machine but once the gas was turned on and ignited it wasn't long before steam began to appear out of the top open end of the inner tube, and the inserted wood warmed up. With Trevor Fordham, Bob Renton and Carol

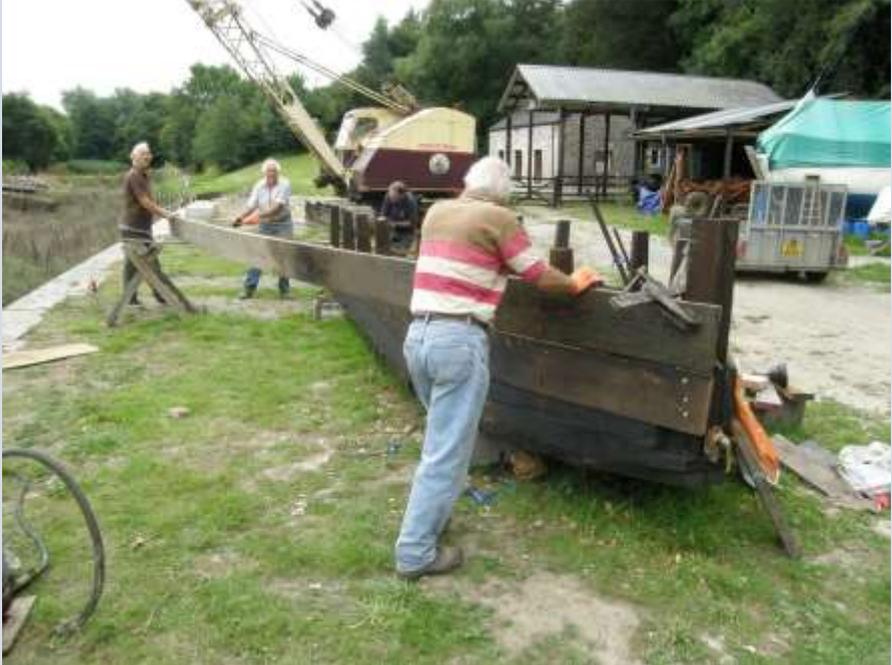
Unwin's help Barry soon managed to get the steamed board clamped to the bow post of the lead boat and pulled around into its final position. Using a variety of clamps, the board was held fast and eventually permanently fixed using a combination of wood bolts and square nails.

Suddenly the tub boat was beginning to look like a proper boat.

From this point it was not too long before both sides were clad. Barry then began putting his mind to making the strengthening knees for the bow. After much measuring he went home armed with various pieces of oak which he was going to introduce to his band saw.

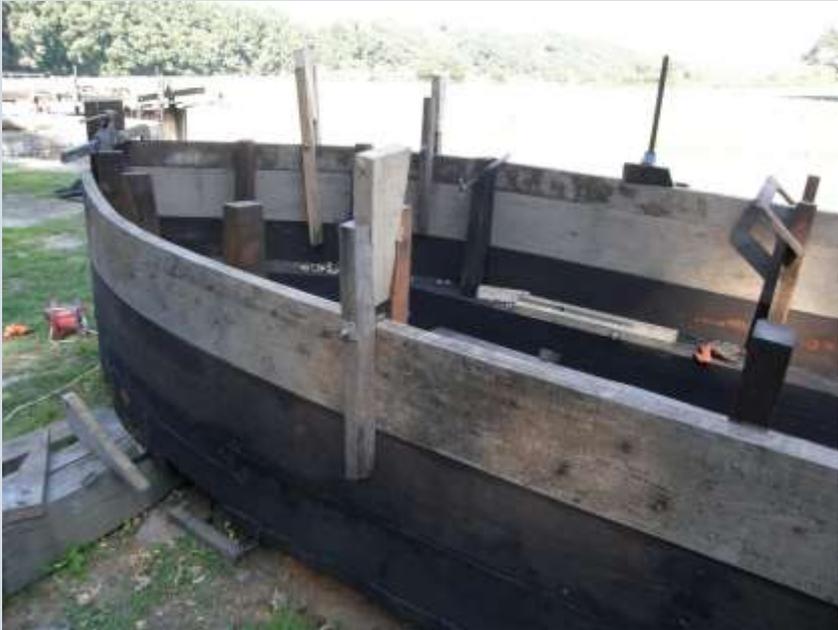
This picture shows one of the 'clothes peg' style clamps, made by Barry, specifically for holding the cladding while it was being bent to shape and fixed in place.

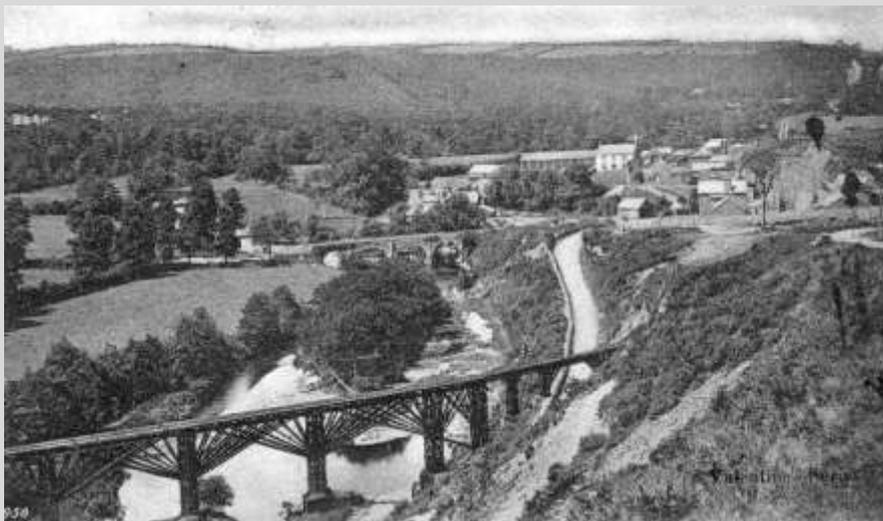
The wooden viaduct shown in the print above is one of a series which carried the light railway from the clay pits at Peters Marland to the station at the foot of Torrington Commons. The course of the now defunct and in-filled Rolle Canal runs underneath this viaduct through the middle of the scene.

The line from Torrington necessitated ten viaducts to reach the Marland clay works, each varying in height and length. Included was the high trestle bridge and viaduct over the river Torridge, a total length of 266 yards and about 40 feet high. (See *print on previous page.*) The rails were 3 feet gauge and the trestle system did away with the need to make expensive cuttings and embankments. The line was opened on the 5th Feb. 1881 where the clay it brought from Marland was transferred to the main line railway. The canal having previously been closed.
