THE ROLLE CANAL & NORTHERN DEVON WATERWAYS SOCIETY

NEWSLETTERNo 13 Jan. 2010

An update on the state of the Canal Leat at Rosemoor and its associated structures - June 2009.

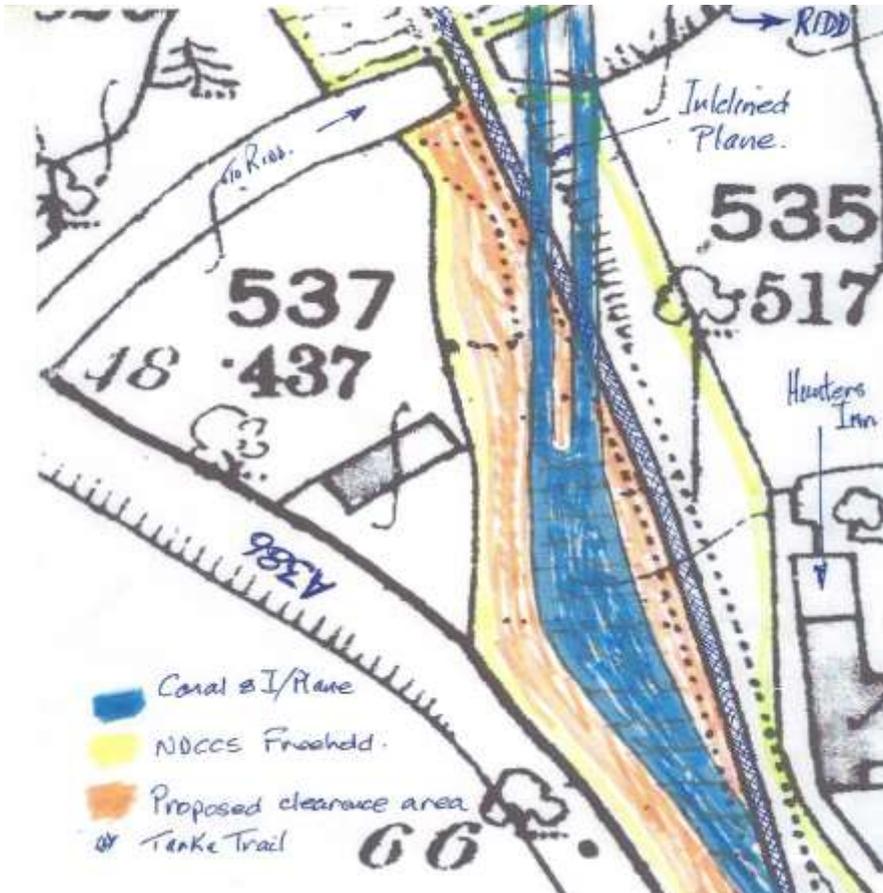
The area was a hive of activity when the canal was running, with a stables, a bridge across the canal connecting the Hunters Inn to the new Torrington Road, and the lime kilns at the rivers edge.

In the map, annotated by David, the inclined plane has been superimposed on the line of the railway (Tarka trail) showing where the top basin is believed to be. The bridge was demolished when the railway was put through, but the parapet can still be clearly seen at the S. end of the Hunters Inn. The building on the W of the Railway is believed to have been a stable, as it was likely that the horses, which would be disconnected from the barges at this point, would need somewhere to be housed , fed and watered. A much smaller building is to be found at the bottom of the plane, where it is unlikely that stabling would be needed after the short journey from Annery, the horses immediately returning to Annery with the down barge, or being walked up to the top.

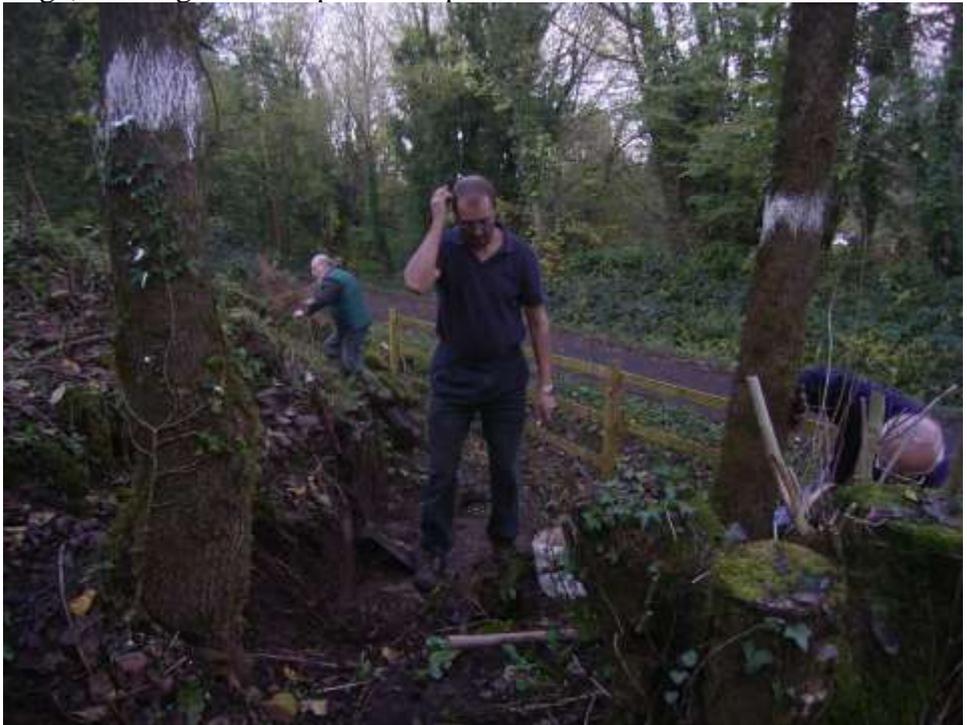
Is this the basin retaining wall ?

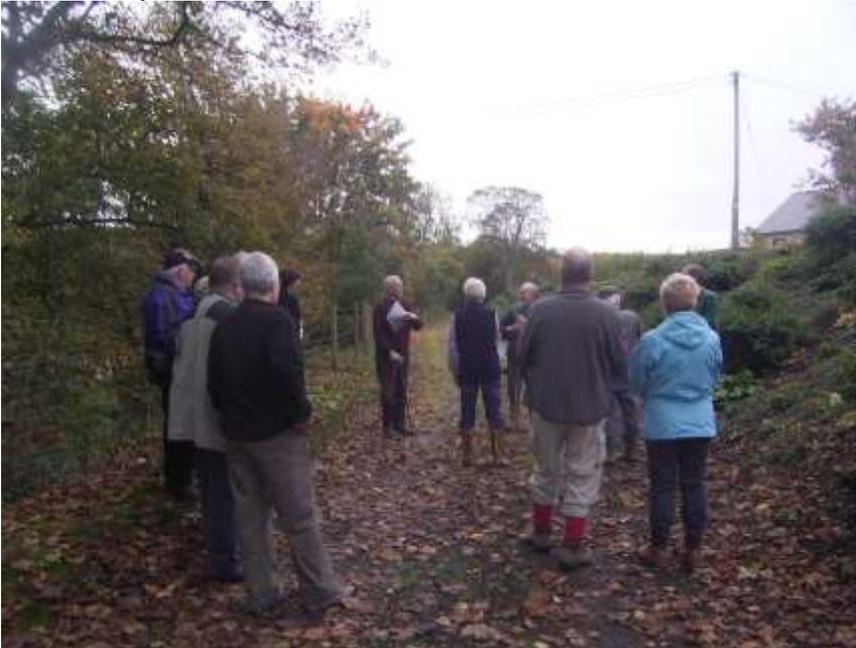
Old bed of the canal (drive to Staple Vale)

There is still a marked indentation in the field as the canal curved round with its thick hedge on top of the old tow-path. It continued on beneath the drive to his house and included a short aqueduct where the canal passed over a stream which descends from Torrington Common. Then it passed under the car parking area in front of the old station which was built for the new railway line and which replaced the canal.

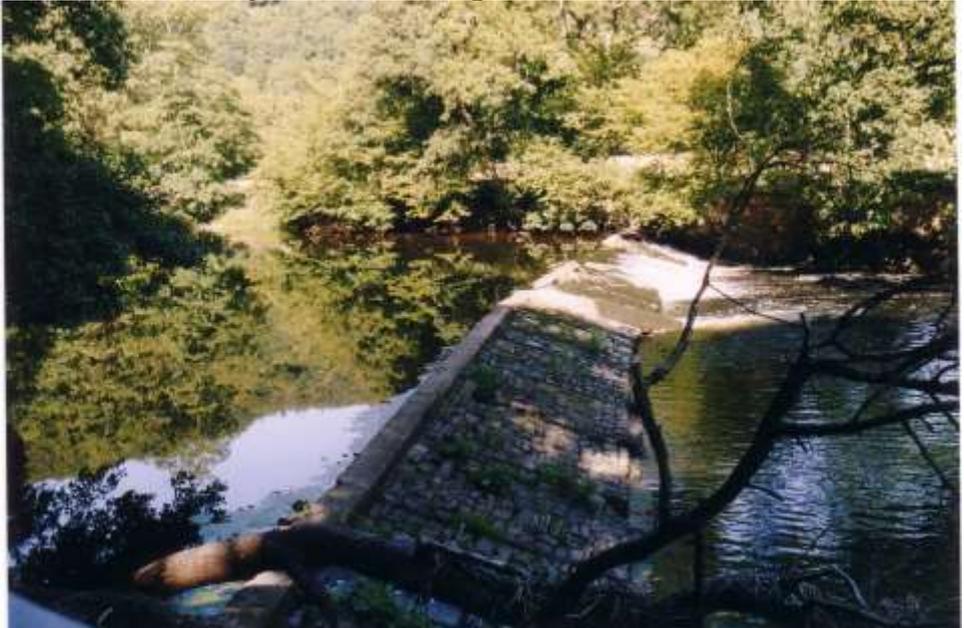
Healand weir

Healand Weir is believed to pre-date the Rolle Canal itself as it was built to raise the level of the Torridge and divert water down the leat to power the Tucking Mill below Rowe's Moor. It was subsequently remodelled in 1837, along with a new quay wall to form Healand Docks. These were at the head of a widened leat bringing canal boats from the basin by the lime kilns right up to the Torridge.

The weir has suffered some erosion, particularly towards the far bank, where the coping stones and quite a lot of the spillway have been washed away through many years of floods. There is a large tree trunk wedged against the near abutment which is causing extra water pressure on part of the stonework adjacent to Lord Rolle's 1837 commemorative stone, and some of the masonry has been dislodged.

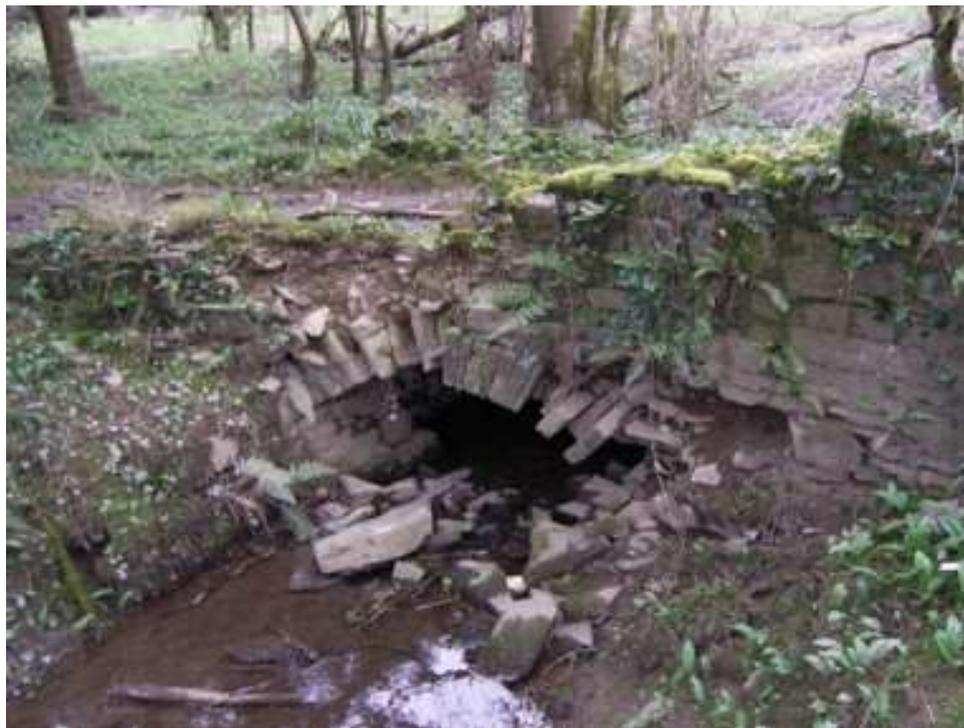
Tucking mill exit channel

Society members did a considerable amount of work excavating the feeder channel, wheelpit and mill race about two years ago, so it is possible to see where the water from the leat ran alongside the structure of the mill to power the wheel, although the building itself is long gone.

The mill race ran under another stone arched bridge to reach the Torridge, but that bridge collapsed under the weight of machinery when the conifer plantation was cleared and it is now replaced by a cast iron pipe bedded in rubble.
