The **R**o **e** **C**ana  
& Northern Devon  
Waterways Society

SOCIETY NEWS & VIEWS

AUTUMN ISSUE

November 2016

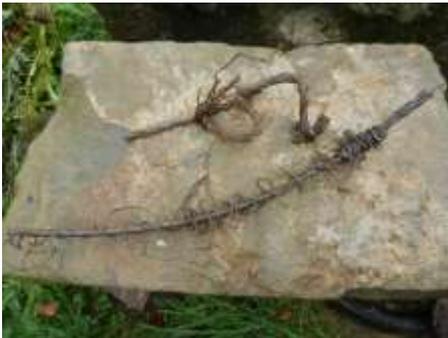
Adrian Wills explains how to get into the swing of things and what this picture has to do with it!

I spent several hours one afternoon working the dragline but couldn't get the bucket as far out as I wanted. On my next attempt, having lowered the boom to give me a little more length from the end of the boom to the crane I managed to swing the bucket out by approximately 15 feet further from the vertical. While Trevor watched the proceedings, I began to drag out a very satisfying amount of silt from alongside the wing wall. It was about this time we both became aware that the dragline rope had broken one of its multi-strands which was happily unwinding itself and creating a 'birds nest'. (Ref. picture on CONTENTS page).

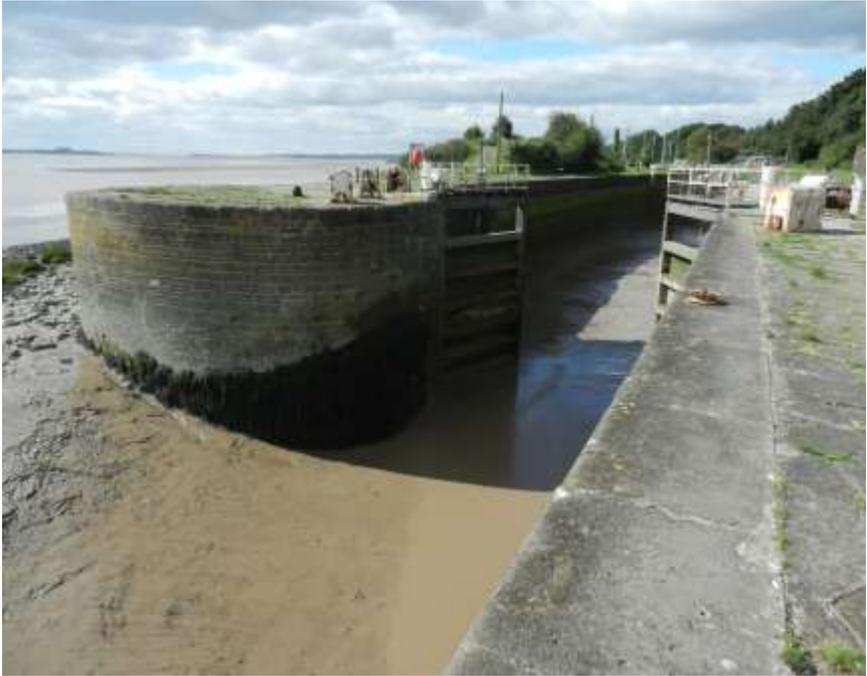
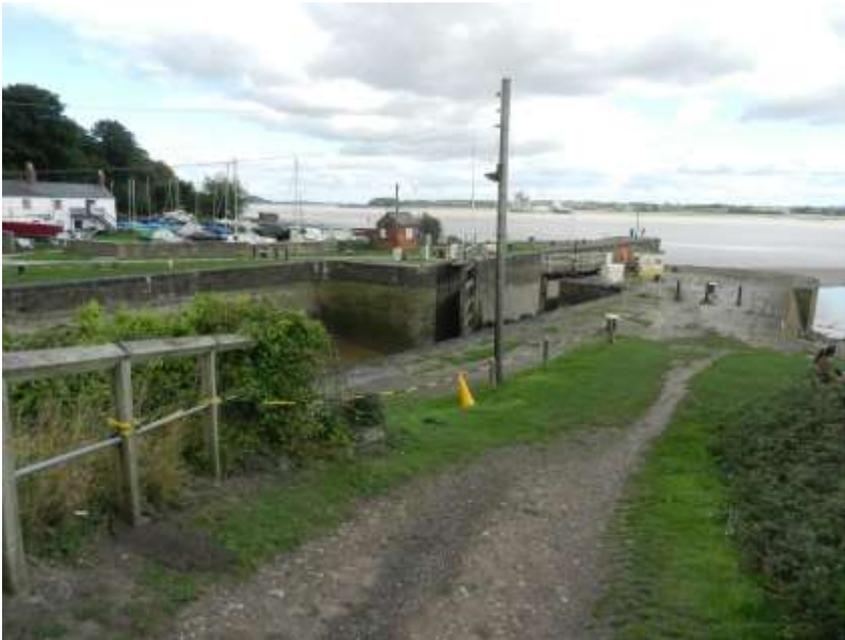
Looking into the Tidal Lock of the Lydney Canal, above. Looking across the River Sever to Sharpness (behind the telegraph pole) from the entrance to Lydney Canal, below.

*In the 1960s imported wood was still being brought in by barge from Avonmouth.<sup>[2]</sup> It remained in commercial use until the 1980s. The entrance to the canal consists of an outer tidal gate opening into a wide basin. From there a lock opens into the one - mile canal cut. Immediately above the lock, a pair of gates point the other way as protection against a high tidal flood in the estuary. There is one swing bridge crossing the canal. The docks have recently been restored to create a marina and harbour area for seagoing yachts and motor boats.<sup>[3]</sup>*

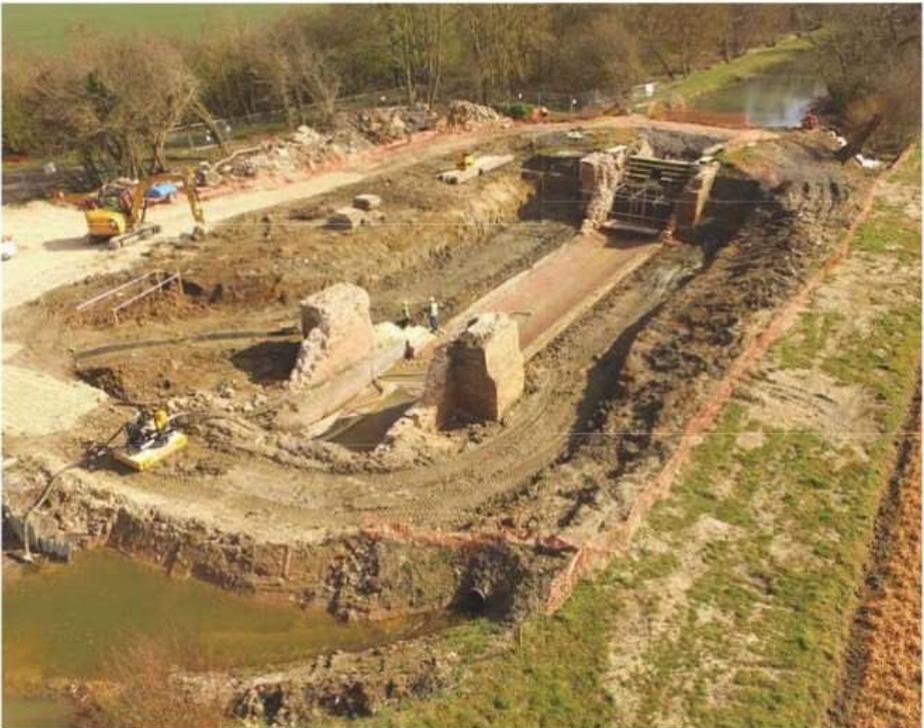
A fabulous overhead photo of Woolsthorpe Middle Lock showing the lock totally reduced down to the invert with only the 4 quoins standing.

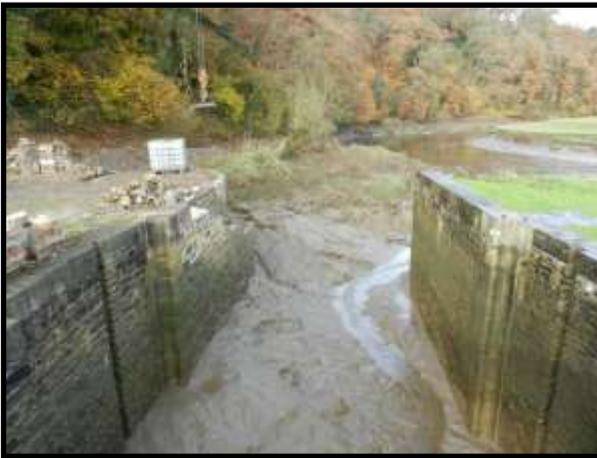
I am convinced that without this huge deposit of silt, which can be seen in the picture opposite, which semi blocks the entrance to the canal, there would have been a natural deep and quiet bay in the river below

which would have been ideal for launching newly built vessels into or to hold vessels waiting to enter the canal.

In between times and tides, the problem of silt deposition on the outside of this section of wall has been thought about. During a recent visit to the site, Norman Richards used the Kubota tractor to clear the overgrown track running along the hillside on the outside of the entrance to the canal. We have discussed at some length as to whether this track was originally part of the ship building 'ways' from when the shipyards were moved from Annery to Sea Lock.

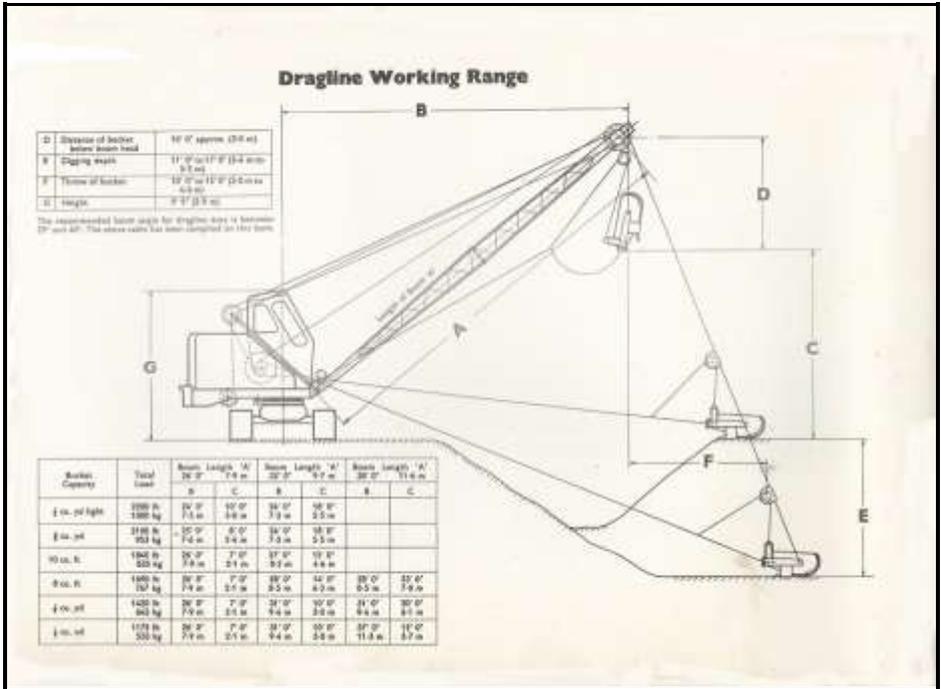
A technical 'how to do it' page from the

**THE PRIESTMAN "CUB" MARK V1 EXCAVATOR  
OPERATIONS AND MAINTENANCE INSTRUCTIONS**

lifting crane which is a simple up or down action, draglining requires 'throwing' the bucket out. This is achieved by raising and releasing the bucket in such a way as to make the bucket swing out and away from the crane as it falls. It is then drawn back towards the crane, effectively scrapping the ground before finally being lifted and emptied to the side.

As the bucket is being swung out, the dragline brake and the lifting brake have to be released to allow their ropes to freely spool off their drums. However a degree of restraint has to be maintained to prevent the drums from over-spooling after the bucket has landed otherwise the ropes slacken off the drums and then tend to overlap, tangle and kink themselves as they are being rewound.

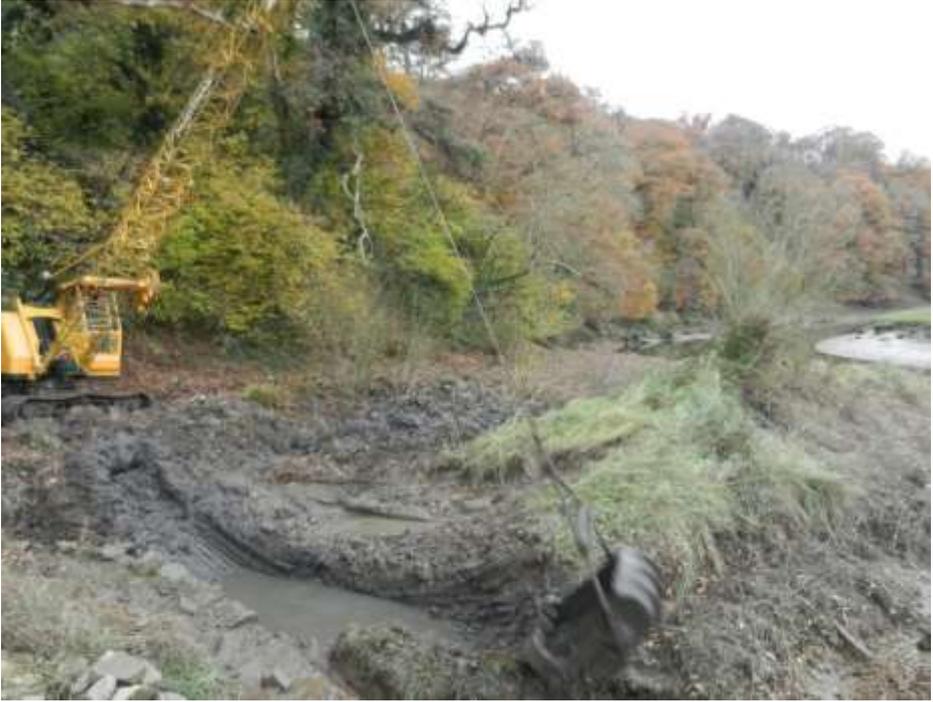
Swinging the dragline bucket out alongside the western wing wall just before the unravelling rope was noticed and work had to be stopped for the day. Picture by T Fordham

When Trevor and I had a good look at the damaged rope, it was indeed in a mess. I was hoping that where it had been kinked, it could be cut off, leaving sufficient length of rope to reattach the bucket and continue as before. It was soon obvious that the rope was damaged so far along its length that the whole thing would need removing and replacing.

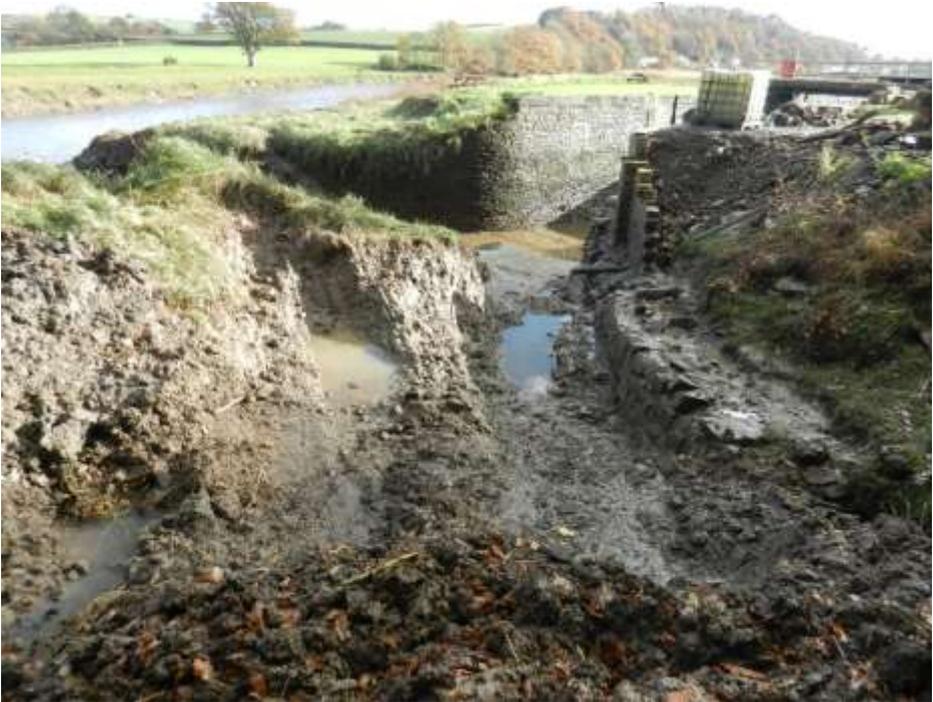
Having dragged out some of the silt which had accumulated against the wing wall, access to the wall for rebuilding purposes is now much easier. However, it has highlighted quite how much needs to be rebuilt, as can be seen above, and how much facing stone and other construction materials are going to be needed to complete this task. Still, it keeps me out of mischief!
